ELECTRICAL SYSTEM

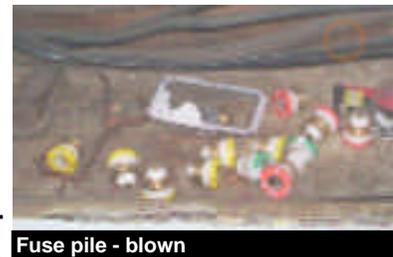
MAIN PANEL
NOTES: **There are signs of rust and moisture entering within the panel. Most of the fuses are double wired and over sized. *This is not safe.* A pile of used and blown fuses are present. *This is an indication of periodic over load of one or more branch circuits.* Additional sub-panels have been added to this system.**

Fuse pile - blown

moisture signs in panel - rust

*** Due to conditions noted, I recommend further review for possible upgrades/ repair of this homes electrical system (main and sub panels) by a licensed and reputable electrician. System evaluation should be done prior to closing.**

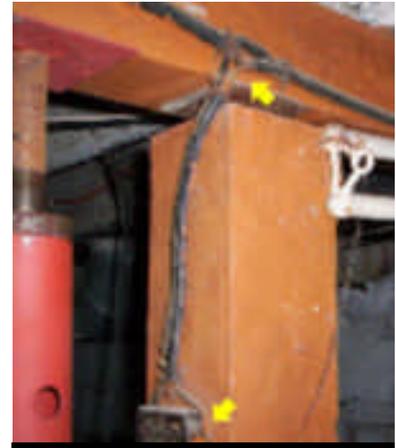
*** There are multiple open wire splices and frayed sheathing throughout the basement and right crawlspace. Do to the extent of the frayed sheathing, **these are not safe.****

Exposed splice and outlet wiring

Photo is representational. More conditions exist.

I recommend servicing of all necessary conditions by a licensed electrician.

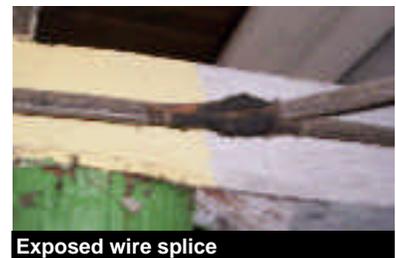
Exposed wire splice

Example of frayed wired sheathing, including but not limited to: the right crawlspace.

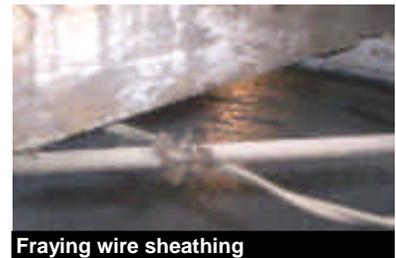
Fraying wire sheathing

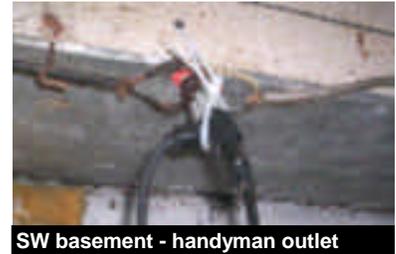
*** The southwest basement sump pump is supplied by a handy-man outlet. The other two sump pumps have no dedicated outlet to serve them. *I recommend servicing for adding necessary outlets.***

SW basement - handyman outlet

*** I recommend servicing and further evaluation of components (any necessary branch wiring, splices, switches, outlets, stove outlet, sump pump outlets, basement lighting considerations, and garage wiring) by a licensed electrician.**
