ROOF SYSTEM

ROOF:

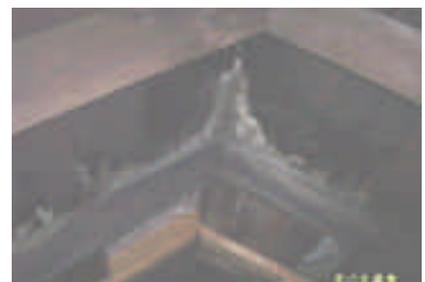
Stains and decay

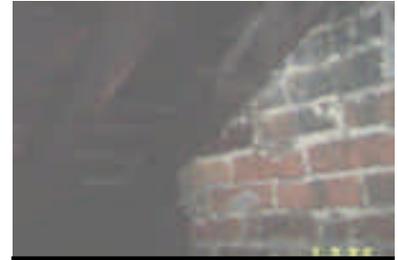
Stains and decay around the chimney area. See ROOF chimney section.

Stains and decay - chimney

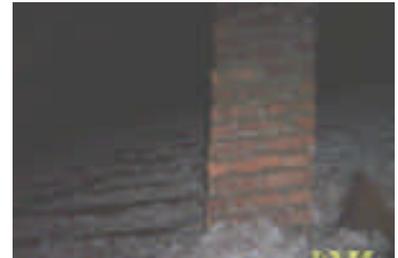
There is an old chimney "dead ended" in the attic. This chimney has a moderate lean. *I recommend further evaluation in regard to its stability.*

Older chimney leaning

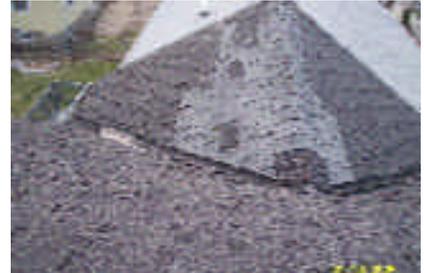
There is patching of the shingles throughout the roof. Valleys are worn.

Patching and valley wear

Due to the advanced age of the shingles and patched areas and conditions noted, I recommend that a reputable licensed roofer make repairs as necessary. Further evaluations of the roof are recommended to be done prior to closing.

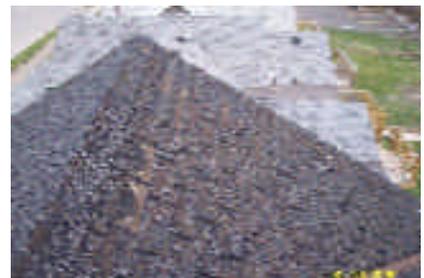
The majority of the shingles show advanced age, cupping, curling, and heavy granule loss.

Advanced aging shingles

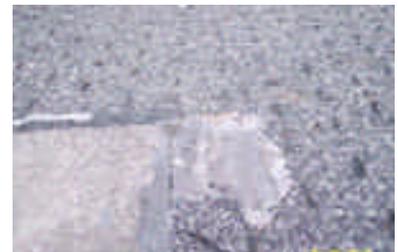
Heavy patching has been done in multiple areas.

Heavy patching

In my opinion, the heavily patched or heavily caulked areas are a temporary repair. This indicates areas that may likely leak in the near future. Regular maintenance is advised.

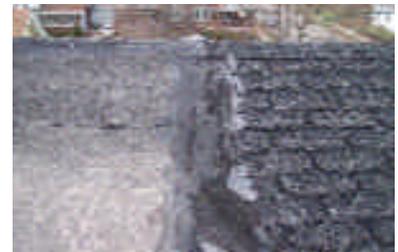
Heavy patching has been done where two different roof materials meet.

Heavy patching

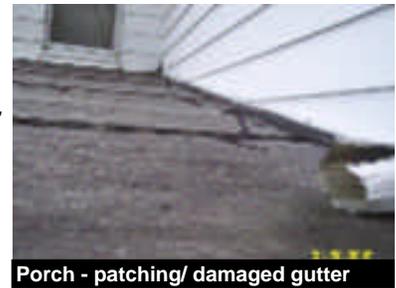
The porch roof coverings are satisfactory. The seams and edges are sealed with a roofing compound. *The roofing compound wears naturally over time. Routine maintenance of these areas is recommended.*

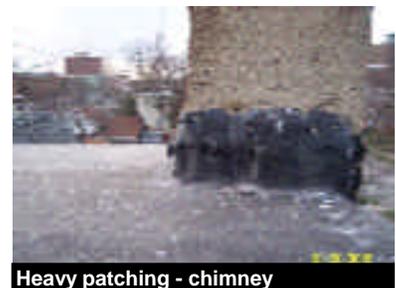
The chimney is heavily patched or caulked at the roof. *In my opinion, this is a temporary repair.* The brick has been patched over or repaired throughout. *I recommend further evaluation and repairs as necessary of the chimney. This should be done by a qualified mason.*

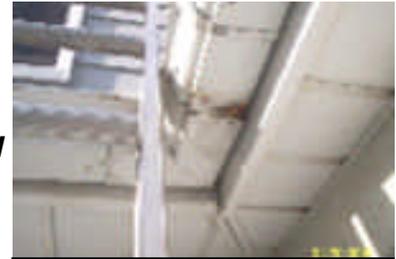
Gutters are installed. Dents are visible. The gutters are pulling away from the structure. Debris in some of the gutter(s). Routine maintenance is recommended to clean debris . This will allow efficient drainage of rainwater in relation to the roof system.

Leaking gutters

I recommend securing all loose gutters and repair of leaking gutters by a licensed roofer or contractor.

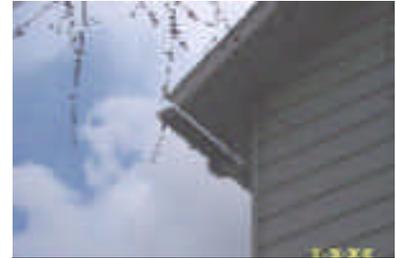
Loose gutters

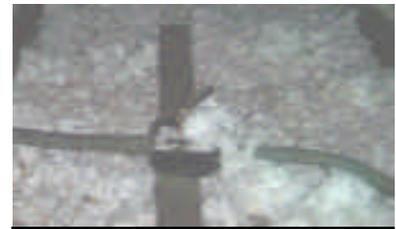
Insulation in junction box

Due to multiple conditions that contradict acceptable knob and tube practices, and areas of splicing: I recommend a licensed electrician to further review the panels and repair any necessary conditions found there and throughout the attic. **This is a fire and safety hazard.**

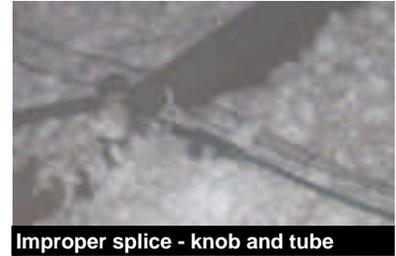
"Live" knob and tube wiring in the attic is improperly spliced in several areas.

"Live" knob and tube wiring was found and routes under the insulation.
