STRUCTURAL

STRUCTURAL:

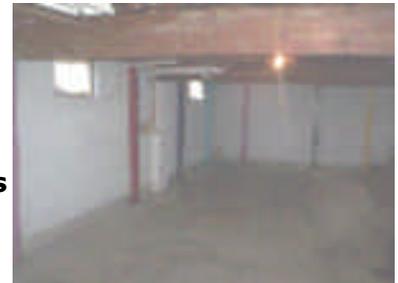
*** Various methods of wall restraint have been used throughout the basement foundation walls. Steel wall braces and anchor wall plates are in use. In some instances, the braces show signs of bowing inward. Examples are along the west foundation wall.**

- * I recommend further evaluation by a structural engineer for additional recommendations prior to closing.**
- * I recommend obtaining history of the home from the sellers.**
- * I recommend obtaining supporting documentation of repairs.**

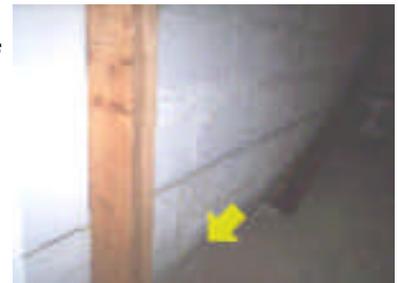
*** The bottom course of block and foundation corners (where the metal of the moisture intrusion system wraps) appear to have inward movement. This includes, but is not limited to, the east, south and southwest foundation walls.**

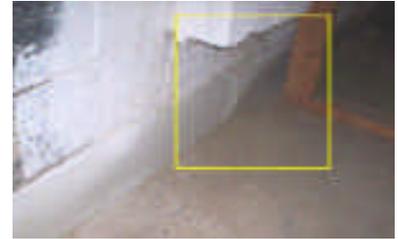
*** The lower block of the east masonry buttress has been removed to allow for the moisture drainage system.**

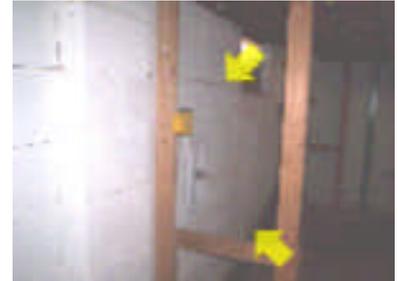
*** The east foundation wall, where the anchor wall plates are in use, has open cracks along the upper and lower courses of block.**

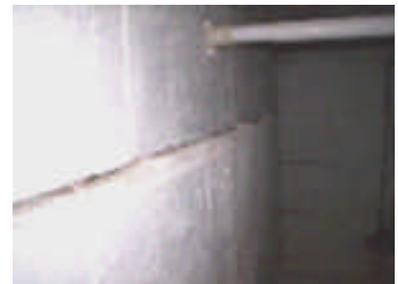
*** The top course of block along the west basement wall shows signs of movement. In some areas, such as by the shower, the block has moved over an inch and a half.**

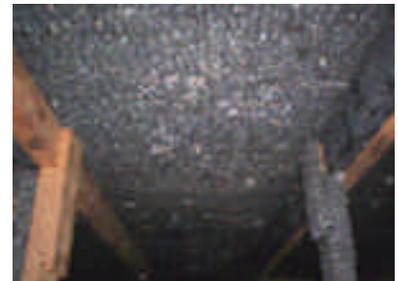
*** As viewed in the attic, the home has previous fire damage.**

*** Rafters and board sheathing throughout the garage and partly over the home are extensively charred.**

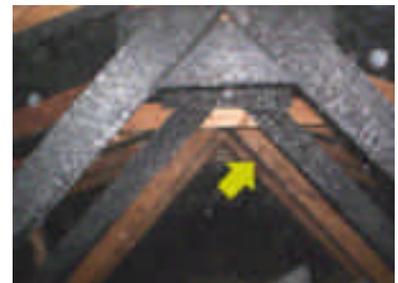
*** Various random repairs have been made throughout the charred areas. It is beyond the scope of inspection to determine if the structural repairs are adequate. Due to the extent of the damage, I randomly probed damaged areas. I did not notice excessive deflection of board sheathing or the rafters.**

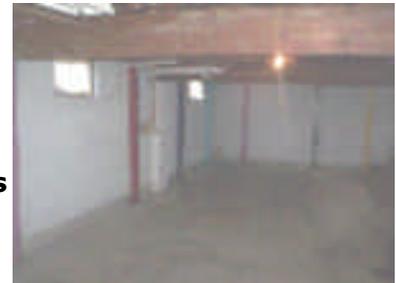
*** Various methods of wall restraint have been used throughout the basement foundation walls. Steel wall braces and anchor wall plates are in use. In some instances, the braces show signs of bowing inward. Examples are along the west foundation wall.**

- * I recommend further evaluation by a structural engineer for additional recommendations prior to closing.**
- * I recommend obtaining history of the home from the sellers.**
- * I recommend obtaining supporting documentation of repairs.**

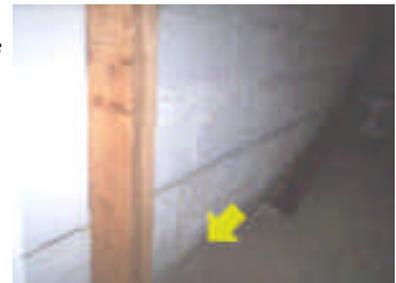
*** The bottom course of block and foundation corners (where the metal of the moisture intrusion system wraps) appear to have inward movement. This includes, but is not limited to, the east, south and southwest foundation walls.**

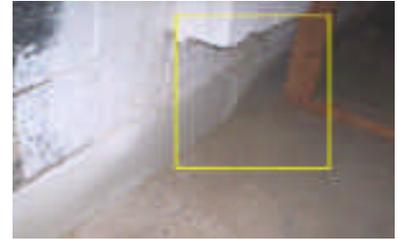
*** The lower block of the east masonry buttress has been removed to allow for the moisture drainage system.**

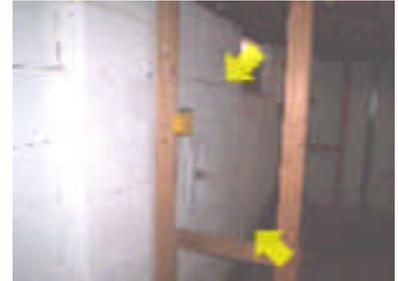
*** The east foundation wall, where the anchor wall plates are in use, has open cracks along the upper and lower courses of block.**

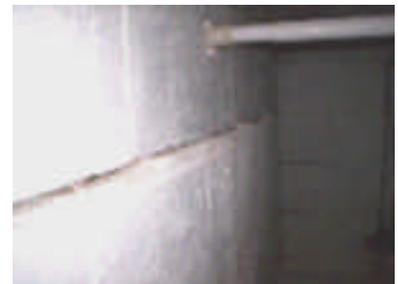
*** The top course of block along the west basement wall shows signs of movement. In some areas, such as by the shower, the block has moved over an inch and a half.**

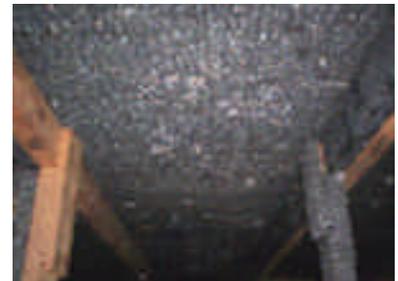
*** As viewed in the attic, the home has previous fire damage.**

*** Rafters and board sheathing throughout the garage and partly over the home are extensively charred.**

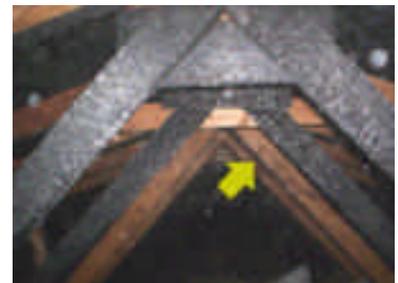
*** Various random repairs have been made throughout the charred areas. It is beyond the scope of inspection to determine if the structural repairs are adequate. Due to the extent of the damage, I randomly probed damaged areas. I did not notice excessive deflection of board sheathing or the rafters.**
